**Flood Control Project Maintenance  
Levee Inspections**

**Maintenance Issue Types Only, Levee Inspection Report By Mile - Spring 2020**

**Sutter Maintenance Yard Maintenance Area 0013**

Waterway	Bank	Unit Miles	Inspection Start/End	Inspector
Unit No. 01 Cherokee Canal	Right	18.19	04/09/2020 04/09/2020	Makar Sokol

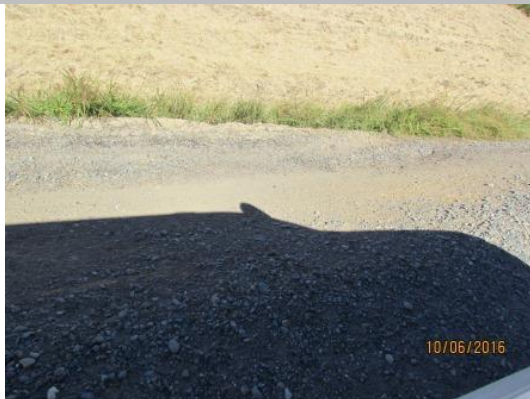
Photo 1 of 1 : SP\_2020\_MA0013\_300\_57\_20200226\_00008.jpg

LM Start	15.58	Rating **	M	Issue No.	57
LM End	15.58	Issue Type +	Ma	Location *	LS
Category	Earthen Levee			GPS Latitude/Longitude	
				Start	End
Item	Slope Stability			39.400380 °	39.400380 °
				-121.808432 °	-121.808432 °
DWR ID	DWR_MA0013_01_f _ 2016_57				
Comment Code					
S1 : Repair slope instability.					
Inspector Comment

View of slope instability along the landside slope.

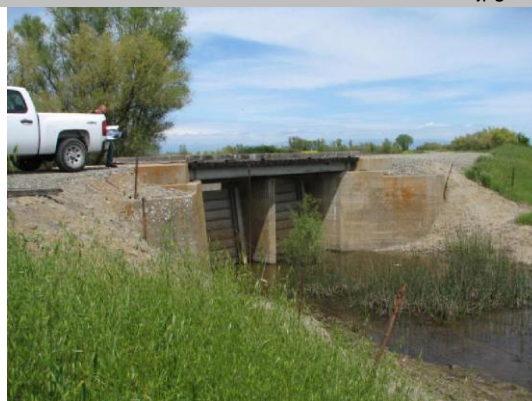
Photo 1 of 3 : UCIP\_SP\_2020\_56094\_74500.jpg

Comment Code						
Inspector Comment						
DS_ID:16372 FS_ID:56094 EP_NO: N/A Repair Type: Non-Urgent Crossing Status: Found UCIP Comments: 08/27/2019 Structure is referenced in Permit Number 11805. Need to pull permit to review details. Need to update structure description to reference correct permit. (O. Magana - DWR UCIP, A. Freitag - DWR Sutter Yard)06/15/2017 Crossing appears to be in good condition. Pipe has been selected to be internally cleaned and inspected as part of the DMP project. (DWR Sutter Yard- AFreitag)11/17/2016 Crossing appears to be in good condition. (DWR Sutter Yard- AFreitag)05/03/2016 Crossing appears to be in good condition.07/13/2015 Crossing appears in good condition. No noticeable issues to report.05/22/2014 Same as last inspection.12/03/2013 Same as last inspection.07/15/2013 Same as last inspection.04/18/2012 The structures are closed with metal stop logs (weir type structure). The stop logs appear to be removable, however; there is a wooden bridge over the structure that would have to be removed in order to raise the stop logs. There is 1-foot of clearance between the bottom of the bridge and the top of the stop logs. FIELD_STRUCT_DESC: Two 10-foot by 10-foot concrete drain openings through the levee at an unknown depth below the crown. Wooden bridge, 10 ton load limit. [Additional Reference(s): DWR Levee Log, 1993 (HLM 16.43). USACE Sacramento O&M Manual 519, June 1962 (HLM 16.43), listed as two 9.9-foot by 9.7-foot concrete conduits, As-built DWG No. 50-4-3511, Sheet No. 3511/27.1, STA 208+02W, page 27 of 31 electronic file, listed as drainage structure] FS Date: 8/27/2019 2:23:00 PM

WS view of structure.

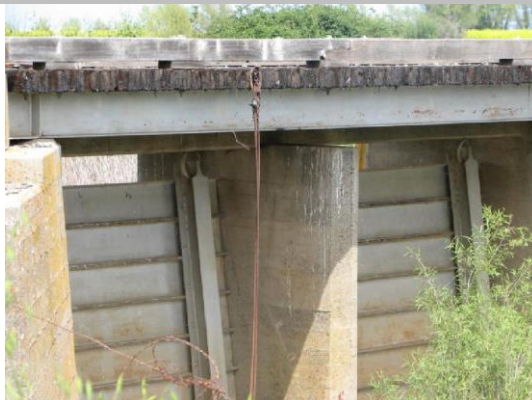
Photo 2 of 3 : UCIP\_SP\_2020\_56094\_74503.jpg

View of crossing and panels attached to concrete walls.

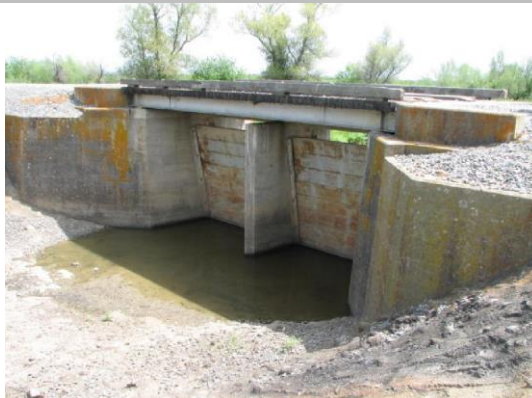
Photo 3 of 3 : UCIP\_SP\_2020\_56094\_74501.jpg

LS view of structure

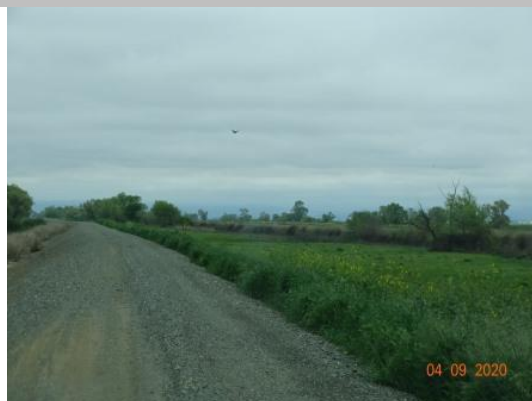
Photo 1 of 1 : SP\_2020\_MA0013\_300\_81\_20200415\_00182.jpg

LM Start	16.96	Rating **	M	Issue No.	81
LM End	18.50	Issue Type +	Ma	Location *	WS
Category	Earthen Levee			GPS Latitude/Longitude	
				Start	End
Item	Vegetation			39.387644 °	39.373427 °
				-121.828223 °	-121.850438 °
DWR ID	DWR_MA0013_01_s_2020_81				
Comment Code					
V1 : Control annual grass and weeds on the levee slopes and easements.					
Inspector Comment

View of the vegetation along the waterside slope. Spring 2020.

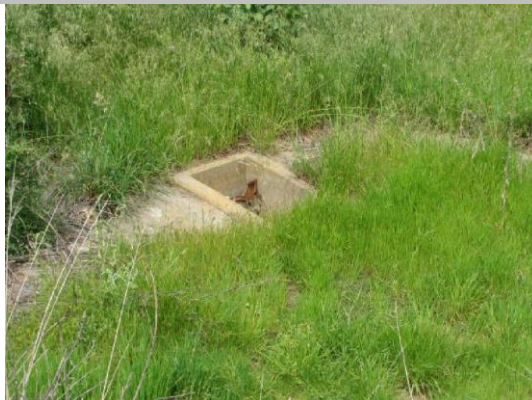
Photo 2 of 3 : UCIP\_SP\_2020\_55006\_67019.jpg

View of WS headwall and flap gate.

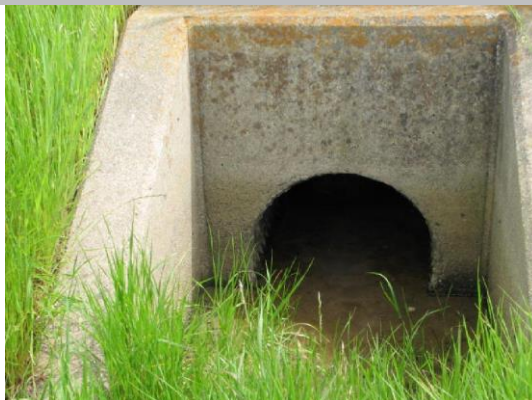
Photo 3 of 3 : UCIP\_SP\_2020\_55006\_67018.jpg

View of LS headwall.

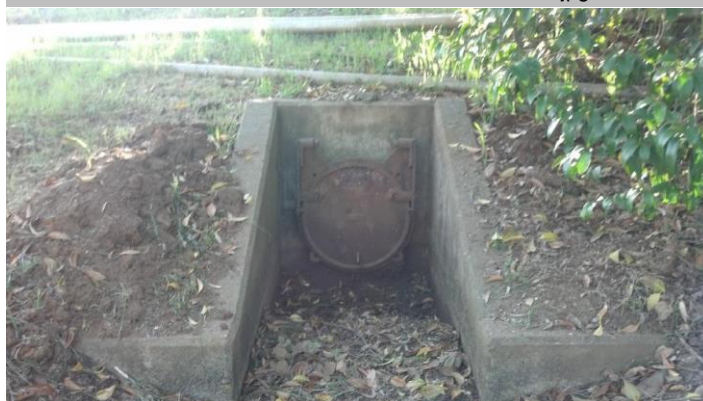
Photo 2 of 3 : UCIP\_SP\_2020\_55415\_45642.jpg

Headwall and flap gate on WS. Soil and pipes stockpiled next to headwall.

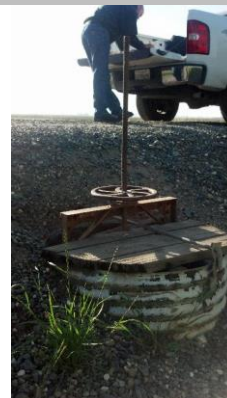
Photo 3 of 3 : UCIP\_SP\_2020\_55970\_67045.jpg

Screw gate located on WS of levee. Screw gate covers needs to be repaired.

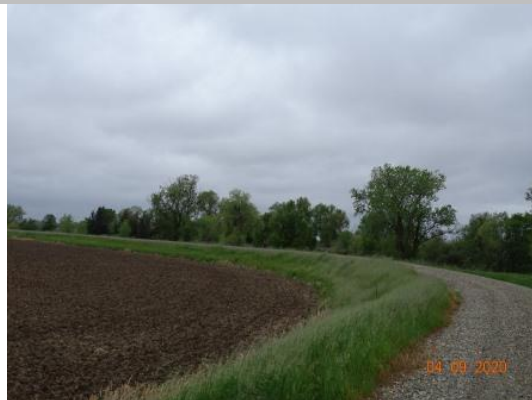
Photo 1 of 1 : SP\_2020\_MA0013\_301\_85\_20200415\_00178.jpg

LM Start	1.67	Rating **	M	Issue No.	85
LM End	1.91	Issue Type +	Ma	Location *	LS
Category	Earthen Levee			GPS Latitude/Longitude	
				Start	End
Item	Vegetation			39.551368 °	39.548161 °
				-121.705344 °	-121.706047 °
DWR ID	DWR_MA0013_02_s _ 2020_85				
Comment Code					
V1 : Control annual grass and weeds on the levee slopes and easements.					
Inspector Comment

View of the vegetation along the landside slope. Spring 2020.

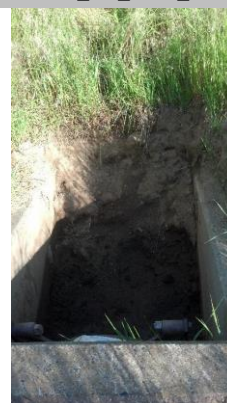
Photo 3 of 3 : UCIP\_SP\_2020\_55416\_67057.jpg

View of WS toe.

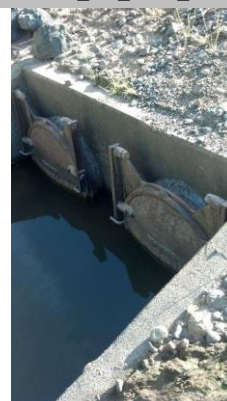
Photo 3 of 3 : UCIP\_SP\_2020\_56150\_67064.jpg

Comment Code					
Inspector Comment					
DS_ID:16400 FS_ID:56150 EP_NO: N/A Repair Type: Non-Urgent Crossing Status: Found UCIP Comments: 08/28/2019 Record has been updated from No Action Needed to Non-Urgent, no permit has been identified authorizing pipe. Pipe is scheduled to be lined. (O. Magana - DWR UCIP, A. Freitag - DWR Sutter Yard)6/5/2017 LS inlet was underwater. WS flap gate blocked shut by sediment. Pipe has been selected to be internally cleaned and inspected as part of the DMP project. (DWR Sutter Yard- AFreitag)11/18/2016 Sediment dug out from in front of flap gate. Gate can now function properly. (DWR Sutter Yard- AFreitag)4/27/2016 WS flap gate still blocked from opening by sediment buildup.7/01/2015 New screw gate installed on the LS. WS flap gate is still blocked from opening by sediment.5/29/2014 Same as last inspection.12/9/2013 Same as last inspection.7/10/2013 Sediment is built up against WS flap gate not allowing it to open. Handle for LS slide gate is still missing.4/19/2012 Handle missing on slide gate. FIELD_STRUCT_DESC: 1 of 2: 36-inch corrugated metal drainage pipe through the levee, 9.7 feet below the crown. Concrete "U" headwalls located on the waterside (WS) and landside (LS) ends. Flap gate on the WS end. Slide gate on the LS end. [Additional Reference(s): DWR Levee Log, 1993 (HLM 2.53). USACE Sacramento O&M Manual 519, June 1962 (HLM 2.54), As-built DWG No. 50-4-3608, Sheet No. 3608/19.1, STA 899+10E LT BK, page 20 of 28 electronic file, listed as two 36-inch CMP; As-built DWG No 50-4-3037 referenced not available] FS Date: 8/28/2019 1:09:00 PM

Headwall and flap gates (2) located on WS

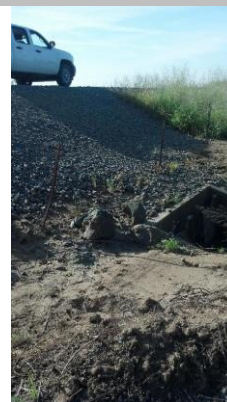
Photo 2 of 3 : UCIP\_SP\_2020\_56095\_67074.jpg

Comment Code						
Inspector Comment						
DS_ID:17169 FS_ID:56095 EP_NO: N/A Repair Type: Non-Urgent Crossing Status: Found UCIP Comments: 08/28/2019 Record has been updated from No Action Needed to Non-Urgent, no permit has been identified authorizing pipe. Pipe is scheduled to be lined. (O. Magana - DWR UCIP, A. Freitag - DWR Sutter Yard)06/05/2017 LS inlet was underwater. WS appears to be in good condition. Pipe has been selected to be internally cleaned and inspected as part of the DMP project. (DWR Sutter Yard-AFreitag)11/18/2016 Crossing appears to be in good condition. (DWR Sutter Yard- AFreitag)04/27/2016 Crossing appears to be in good condition.07/01/2015 New screw gate installed on the LS. WS appears to be in good condition.05/29/2014 Same as last inspection.12/09/2013 Same as last inspection.07/10/2013 Same as last inspection. FIELD_STRUCT_DESC: 2 of 2: 36-inch corrugated metal drainage pipe through the levee, 9.7 feet below the crown. Concrete "U" headwalls on both the waterside (WS) and landside (LS) ends. Flap gate on the waterside (WS) end. Slide gate on the landside (LS) end. [Additional Reference(s): DWR Levee Log, 1993 (HLM 2.53). USACE Sacramento O&M Manual 519, June 1962 (HLM 2.54), As-built DWG No. 50-4-3608, Sheet No. 3608/19.1, STA 899+10E LT BK, page 20 of 28 electronic file, listed as two 36-inch CMP; As-built DWG No 50-4-3037 referenced not available] FS Date: 8/28/2019 1:11:00 PM

View of WS slope.

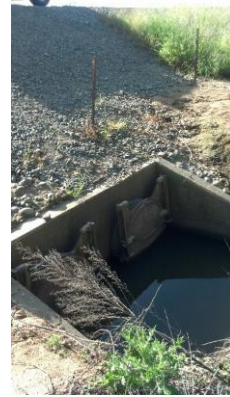
Photo 3 of 3 : UCIP\_SP\_2020\_56095\_67071.jpg

Headwall and flap gates (2) located on the WS.

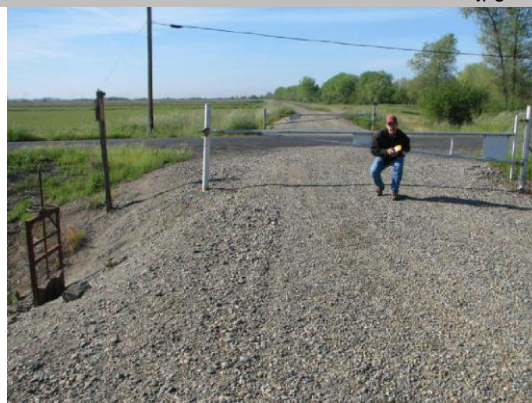
Photo 1 of 3 : UCIP\_SP\_2020\_56096\_67077.jpg

DS\_ID:16402  
FS\_ID:56096  
EP\_NO: N/A  
Repair Type: Non-Urgent  
Crossing Status: Found  
UCIP Comments: 08/28/2019 Record remains Non-Urgent, no permit has been identified authorizing pipe. Pipe is scheduled to be lined (O. Magana - DWR UCIP, A. Freitag - DWR Sutter Yard)06/05/2017 Sediment blocking LS slide gate from closing fully. Pipe has been selected to be internally cleaned and inspected as part of the DMP project. (DWR Sutter Yard- A.Freitag)11/18/2016 Sediment still blocking screw gate from fully closing. (DWR Sutter Yard- A.Freitag)04/27/2016 LS slide gate is full of sediment and needs to be dug out so gate can close fully.07/01/2015 LS screw gate is still silted in and unable to be screwed down all the way. Needs to be cleaned out.05/29/2014 Same as last inspection.12/09/2013 WS flap gate was closed but LS slide gate is heavily vegetated and blocked from closing by sediment.07/10/2013 Same as last inspection.04/19/2012 Minor sediment built up on LS, remove sediment. Need photo of LS slide gate without sediment build up. This crossing was listed in the USACE Periodic Inspection report as Corp's inspect ID# USACE\_CESPK\_M13G\_2011\_p\_0148 for LS gate obstructed by vegetation and WS flap gate is not functioning (propped open).

Overview looking south from left levee

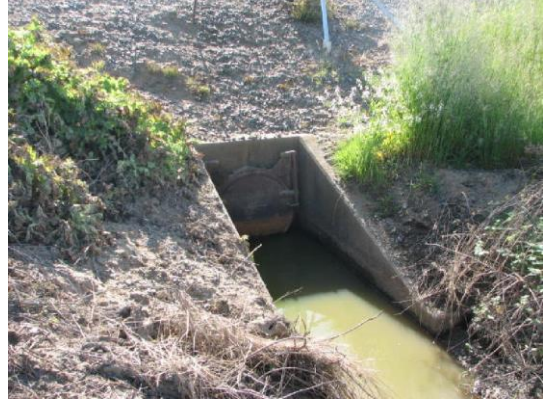
Photo 2 of 3 : UCIP\_SP\_2020\_56096\_67076.jpg

Headwall and flap gate located on WS.

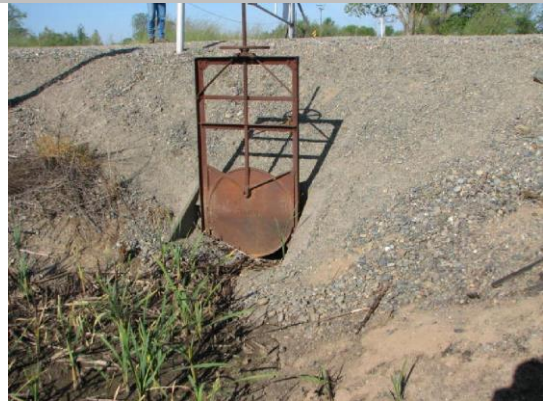
Photo 3 of 3 : UCIP\_SP\_2020\_56096\_67078.jpg

Headwall and screw gate located on LS.

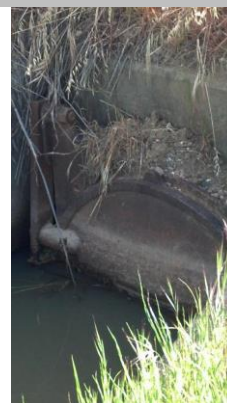
Photo 2 of 3 : UCIP\_SP\_2020\_55093\_67084.jpg

DS\_ID:16403  
FS\_ID:55093  
EP\_NO: N/A  
Repair Type: Non-Urgent  
Crossing Status: Found  
UCIP Comments: 08/28/2019 Record remains Non-Urgent, no permit has been identified authorizing pipe. Pipe is scheduled to be lined. (O. Magana - DWR UCIP, A. Freitag - DWR Sutter Yard)06/05/2017 Crossing appears to be in good condition. Pipe has been selected to be internally cleaned and inspected as part of the DMP project. (DWR Sutter Yard- AFreitag)11/18/2016 Crossing appears to be in good condition. (DWR Sutter Yard- AFreitag)04/27/2016 Crossing appears to be in good condition.07/01/2015 WS flap gate is partially blocked by sediment and needs to be cleaned.05/29/2014 Same as last inspection.12/09/2013 Same as last inspection.07/10/2013 LS and WS slopes have been cleared of vegetation and are in good condition.04/19/2012 Burrowing holes located above WS headwall. Limited inspection on WS and LS slopes due to dense vegetation. Need photos of cleared WS & LS slopes.

Headwall and flap gate located on WS

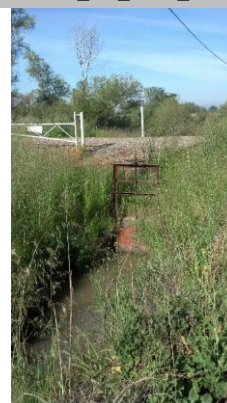
Photo 3 of 3 : UCIP\_SP\_2020\_55093\_67086.jpg

Headwall and screw gate located on the LS

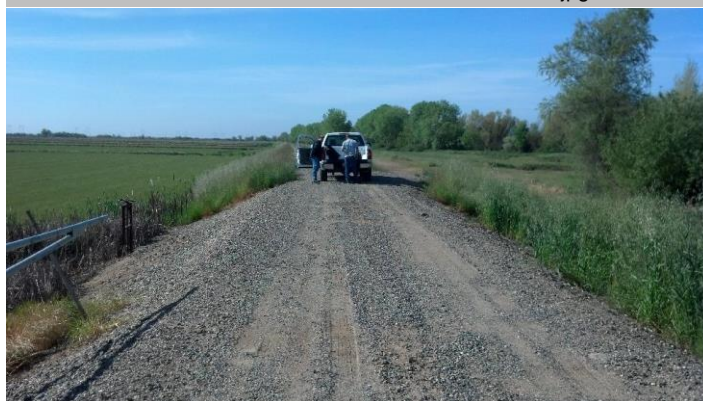
Photo 1 of 3 : UCIP\_SP\_2020\_55094\_67090.jpg

Comment Code					
Inspector Comment					
DS_ID:16415 FS_ID:55094 EP_NO: N/A Repair Type: Non-Urgent Crossing Status: Found UCIP Comments: 08/28/2019 Record remains Non-Urgent, no permit has been identified authorizing pipe. Both inlet/outlet were underwater during inspection. Pipe is scheduled to be lined. (O. Magana - DWR UCIP, A. Freitag - DWR Sutter Yard)6/5/2017 Both gates partially submerged during site visit. Appears to be in good condition. Pipe has been selected to be internally cleaned and inspected as part of the DMP project. (DWR Sutter Yard- AFreitag)11/18/2016 LS screw gate closed but partially buried. WS flap gate was half submerged for inspection. (DWR Sutter Yard- AFreitag)04/27/2016 Both gates were underwater for inspection.07/01/2015 WS flap gate is partially held open by sediment and needs to be dug out to allow it to fully close.05/29/2014 Same as last inspection.12/09/2013 Both gates were out of water and in good condition.07/10/2013 LS and WS slopes are in good condition. Both LS and WS gates were fully submerged in water and unable to be inspected. FIELD_STRUCT_DESC: 36-inch corrugated metal drainage pipe through the levee, 9 feet below the crown. Concrete "U" headwall on both waterside (WS) and landside (LS) ends. Flap gate on the WS end. Slide gate on the LS. [Additional Reference(s): DWR Levee Log, 1993 (HLM 2.65). USACE Sacramento O&M Manual 519, June 1962 (HLM 2.66), As-built DWG No. 50-4-3608, Sheet No. 3608/19.1, STA 891+80E LT BK, page 20 of 28 electronic file, listed as 36-inch CMP; As-built DWG No 50-4-3037 referenced not available] FS Date: 8/28/2019 1:16:00 PM

Overview looking south from left levee

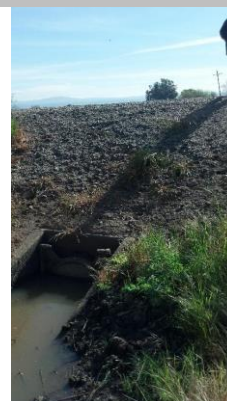
Photo 2 of 3 : UCIP\_SP\_2020\_55094\_67091.jpg

Headwall and flap gate located on WS.

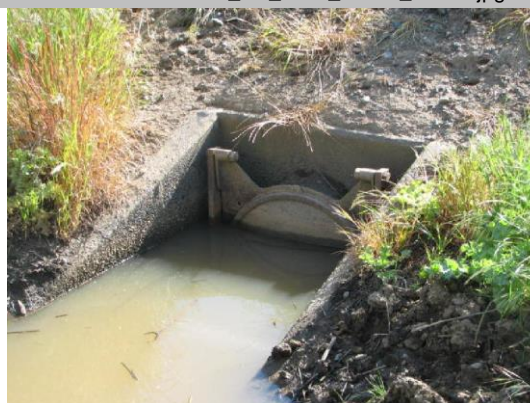
Photo 3 of 3 : UCIP\_SP\_2020\_55094\_67092.jpg

WS headwall and flap gate.

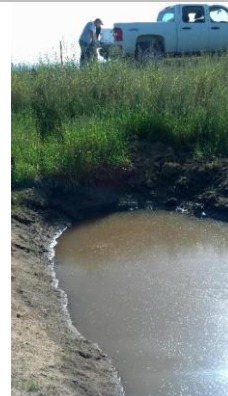
Photo 2 of 3 : UCIP\_SP\_2020\_55095\_67095.jpg

07/10/2013 LS and WS slopes have been cleared by vegetation and are in good condition. WS flap gate is out of water but is blocked from opening by sediment build up. LS gate is fully submerged and not able to be inspected.04/19/2012 Non-functioning crossing. Farmer uses pipe located at LM 3.682 to drain field & not this one. Dense vegetation- need photos of cleared WS & LS slopes. This crossing was listed in the USACE Periodic Inspection report as Corp's inspect ID#

Flap gate submerged in water on WS of levee

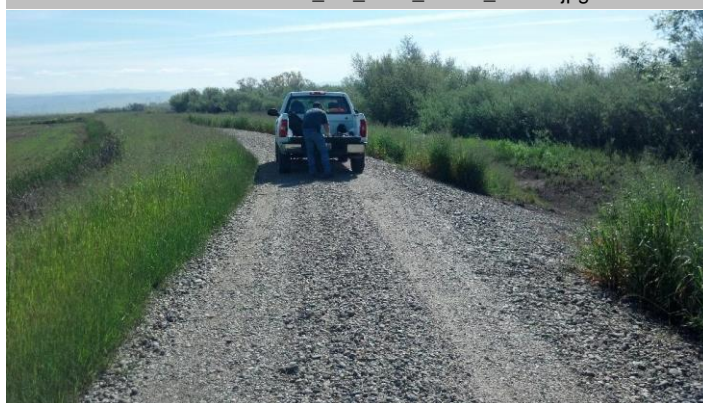
Photo 1 of 3 : UCIP\_SP\_2020\_55096\_67102.jpg

DS\_ID:16848  
FS\_ID:55096  
EP\_NO: N/A  
Repair Type: Non-Urgent  
Crossing Status: Found  
UCIP Comments: 08/28/2019 Record has been updated from No Action Needed to Non-Urgent, no permit has been identified authorizing pipe. Pending internal inspection under DMP Phase 1 both inlet and outlet underwater. (O. Magana - DWR UCIP, A. Freitag - DWR Sutter Yard)06/05/2017 Both ends submerged but appear to be in good condition. Pipe has been selected to be internally cleaned and inspected as part of the DMP project. (DWR Sutter Yard-AFreitag)11/18/2016 Crossing appears to be in good condition. (DWR Sutter Yard- AFreitag)04/27/2016 Crossing appears to be in good condition. New slide gate installed on LS.07/01/2015 Both gates were still submerged in water. Levee slopes were in good condition.05/29/2014 Same as last inspection.12/09/2013 Same as last inspection.07/10/2013 LS slope has been cleared of vegetation and is in good condition. Both gates are still underwater and not able to be inspected.04/19/2012 Dense vegetation makes it difficult to evaluate the condition of the LS slope. Both gates underwater. Recommend taking photos of clear slopes and gates during fall inspection.

Overview looking south on left levee

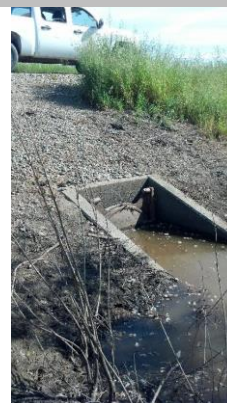
Photo 2 of 3 : UCIP\_SP\_2020\_55096\_67103.jpg

Headwall and flap gate located on WS.

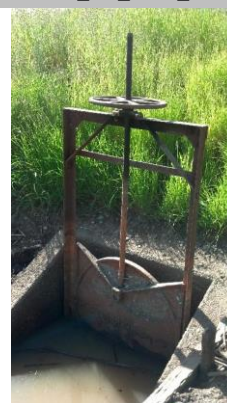
Photo 3 of 3 : UCIP\_SP\_2020\_55096\_67101.jpg

Headwall and screw gate located on LS.

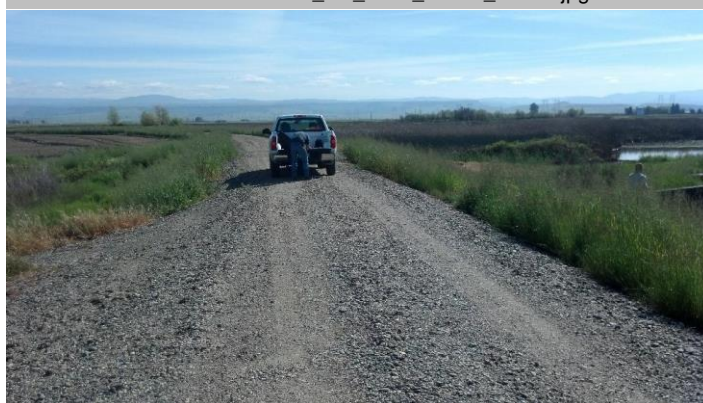
Photo 1 of 3 : UCIP\_SP\_2020\_55097\_67107.jpg

DS_ID:16847 FS_ID:55097 EP_NO: N/A Repair Type: Non-Urgent Crossing Status: Found UCIP Comments: 08/28/2019 Record remains Non-Urgent, no permit has been identified authorizing pipe. Pending internal inspection under DMP Phase 1 both inlet and outlet underwater. (O. Magana - DWR UCIP, A. Freitag - DWR Sutter Yard)06/05/2017 Both ends submerged but crossing appears to be in good condition. (DWR Sutter Yard- A.Freitag)11/18/2016 Crossing appears to be in good condition. It appears that this crossing does not require a slide gate. (DWR Sutter Yard- A.Freitag)04/27/2016 LS slide gate was still missing. Rest of crossing appears to be in good condition.07/01/2015 There appears to be a LS gate now but both pipe ends were submerged so it was hard to tell for certain.05/29/2014 Same as last inspection.12/09/2013 Pulled sticks from WS flap gate to allow it to close. LS gate is still missing.07/10/2013 WS and LS slopes have been cleared of vegetation and are in good condition. LS gate is still missing and WS flap gate is still wedged open with sticks.04/19/2012 LS gate missing & limited inspection. Need photos of WS & LS cleared slopes. Description calls for slide gate on LS-slide gate missing. Debris scattered near LS headwall. This crossing was listed in the USACE Periodic Inspection report as Corp's Inspect ID# USACE_CESPK_M13J_2011_p_0010 for WS gate wedged open & missing LS slide gate. FIELD_STRUCT_DESC: 36-inch corrugated metal drainage pipe through the levee, 8.8 feet below the crown. Flap gate on the waterside (WS) end. Slide gate on the landside (LS) end. Concrete "U" headwalls on both ends. [Additional Reference(s): DWR Levee Log, 1993 (HLM 3.85). USACE Sacramento O&M Manual 519, June 1962 (HLM 3.85), As-built DWG No. 50-4-3608, Sheet No. 3608/5.2, 19.1, STA 16+85C RT. BK. (Cottonwood), page 5, 20 of 28 electronic file, listed as 36-inch pipe] FS Date: 8/28/2019 1:21:00 PM

Overview looking south on left levee

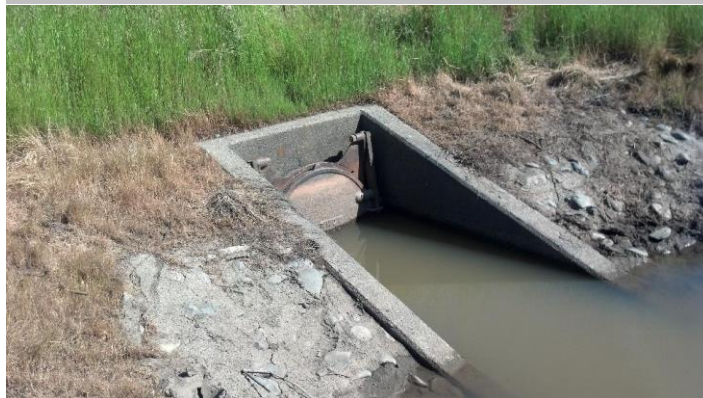
Photo 2 of 3 : UCIP\_SP\_2020\_55097\_67108.jpg

Headwall and flap gate located on WS toe.

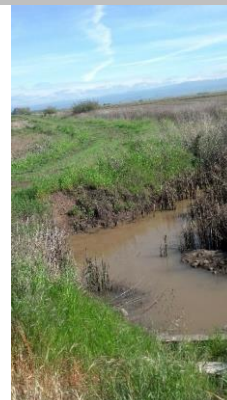
Photo 3 of 3 : UCIP\_SP\_2020\_55097\_67110.jpg

View of channel at crossing looking D/S.

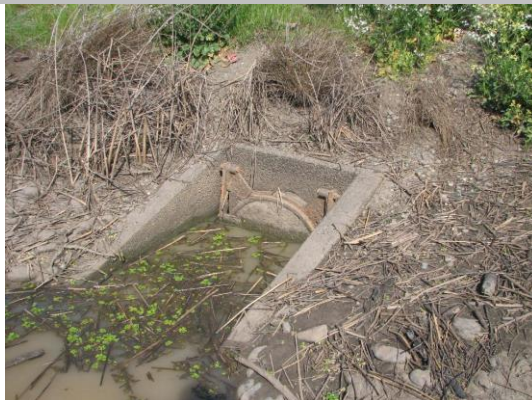
Photo 2 of 3 : UCIP\_SP\_2020\_55098\_67116.jpg

DS\_ID:16846  
FS\_ID:55098  
EP\_NO: N/A  
Repair Type: Non-Urgent  
Crossing Status: Found  
UCIP Comments: 08/28/2019 Record remains Non-Urgent due to potential levee threat. Minor scour was visible on both WS and LS toe. No permit has been identified authorizing pipe. Pending internal inspection under DMP Phase 1 both inlet and outlet underwater. (O. Magana - DWR UCIP, A. Freitag - DWR Sutter Yard)6/5/2017 Both ends submerged during site visit. Pipe has been selected to be internally cleaned and inspected as part of the DMP project. (DWR Sutter Yard- A.Freitag)11/18/2016 Both pipe ends underwater for this inspection. (DWR Sutter Yard- A.Freitag)04/27/2016 Both pipe ends were underwater for inspection.07/01/2015 Both pipe ends and gates were fully submerged.05/29/2014 Same as last inspection.12/09/2013 Same as last inspection.07/10/2013 WS slope is cleared of vegetation and is in good condition. Both gates were fully submerged under water and unable to be inspected.04/19/2012 Rodent activity caused partial collapse on LS of levee in the vicinity of pipe. Limited inspection on WS slope due to dense vegetation. Limited inspection on gates due to both gates submerged under water.

Unable to determine condition of flap gate on WS due to high water.

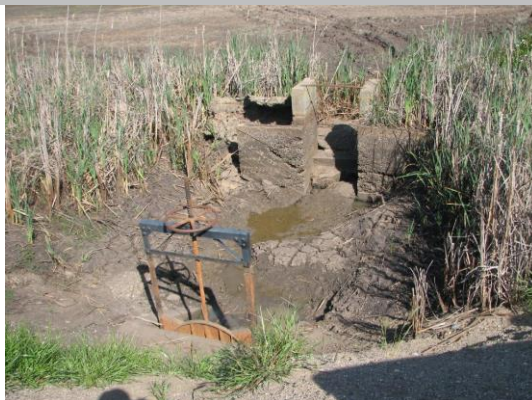
Photo 3 of 3 : UCIP\_SP\_2020\_55098\_67113.jpg

Overview of LS screw gate and concrete sump structure.

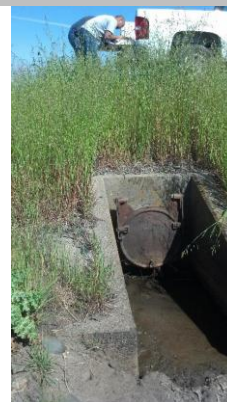
Photo 2 of 3 : UCIP\_SP\_2020\_55099\_67122.jpg

Headwall and flap gate located on WS.

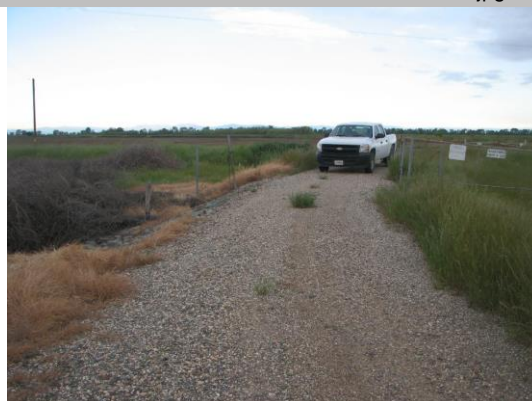
Photo 1 of 3 : UCIP\_SP\_2020\_56098\_67131.jpg

Comment Code						
Inspector Comment						
DS_ID:16395 FS_ID:56098 EP_NO: N/A Repair Type: Non-Urgent Crossing Status: Found UCIP Comments: 08/28/2019 Record has been updated from No Action Needed to Non-Urgent, no permit has been identified authorizing pipe. Pipe is scheduled to be lined. (O. Magana - DWR UCIP, A. Freitag - DWR Sutter Yard)06/05/2017 WS mostly submerged but crossing appears to be in good condition.(DWR Sutter Yard- AFreitag)11/18/2016 Crossing appears to be in good condition. Pipe is a 30" cmp. (DWR Sutter Yard- AFreitag)04/27/2016 Crossing appears to be in good condition.06/30/2015 Erosion on LS does not appear to be getting any worse with the rip-rap there. WS pipe end and gate appeared in good condition.05/29/2014 Same as last inspection.12/09/2013 Same as last inspection.07/09/2013 Same as last inspection.04/19/2012 Rusted pipe debris located on WS. Remove pipe debris on WS and monitor the LS erosion near headwall. Rip-rap used to protect LS headwall from erosion. Was pipe exposed prior to dumping rock? Erosion on the LS could have exposed pipe. Dense shrub on the LS could restrict flow. FIELD_STRUCT_DESC: 30-inch corrugated metal drainage pipe through the levee, 8.6 feet below the crown. Flap gate on the waterside (WS) end. Concrete "U" headwalls on both ends. [Additional Reference(s): DWR Levee Log, 1993 (HLM 5.06), listed as 3-inch pipe. USACE Sacramento O&M Manual 519, June 1962 (HLM 5.06), listed as 30-inch pipe] FS Date: 8/28/2019 3:04:00 PM

Overview looking west on the left levee of Cottonwood

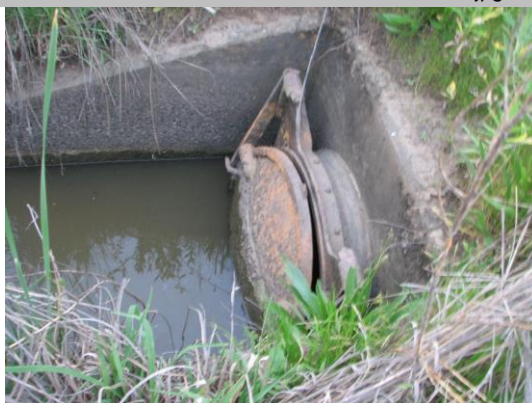
Photo 2 of 3 : UCIP\_SP\_2020\_56098\_67129.jpg

Headwall and flap gate located on WS.

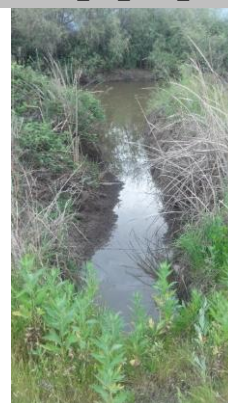
Photo 3 of 3 : UCIP\_SP\_2020\_56098\_67126.jpg

View of channel at crossing.

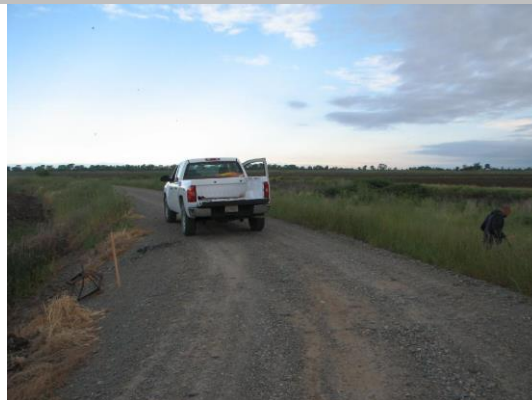
Photo 1 of 3 : UCIP\_SP\_2020\_56101\_67138.jpg

Comment Code						
Inspector Comment						
DS_ID:16408 FS_ID:56101 EP_NO: N/A Repair Type: Non-Urgent Crossing Status: Found UCIP Comments: 08/28/2019 Record has been updated from No Action Needed to Non-Urgent, no permit has been identified authorizing pipe. Pipe has been lined. (O. Magana - DWR UCIP, A. Freitag - DWR Sutter Yard)06/05/2017 Crossing appears to be in good condition. Pipe has been selected to be internally cleaned and inspected as part of the DMP project. (DWR Sutter Yard- A.Freitag)11/18/2016 Crossing appears to be in good condition. (DWR Sutter Yard- A.Freitag)04/27/2016 Crossing appears to be in good condition.06/30/2015 Crossing appears to be in good condition. No apparent issues to report.05/29/2014 Same as last inspection.12/9/2013 Same as last inspection.07/09/2013 WS and LS slopes have been cleared of vegetation and are in good condition. Slide gate on LS has been replaced.04/24/2012 Slide gate is damaged, needs to be replaced. Limited inspection on WS slope and toe due to dense vegetation. Need photos of clear WS slope and toe. This crossing was listed in the USACE Periodic Inspection report as Corp's inspection ID# USACE_CESPK_M13H_2011_p_0026 for broken gate on LS. FIELD_STRUCT_DESC: 24-inch CIPP-lined corrugated metal drainage pipe through the levee, 5.7 feet below the crown. Flap gate on the waterside (WS). Slide gate on the landside (LS). Concrete "U" headwalls located on both WS and LS ends. [Additional Reference(s): DWR Levee Log, 1993 (HLM 5.13). USACE Sacramento O&M Manual 519, June 1962 (HLM 5.13), listed as 24-inch pipe] FS Date: 8/28/2019 3:11:00 PM

Overview of levee crown at crossing looking west.

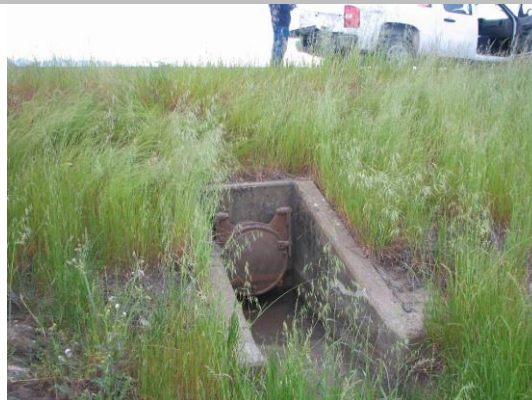
Photo 2 of 3 : UCIP\_SP\_2020\_56101\_67140.jpg

Headwall and flap gate located on WS.

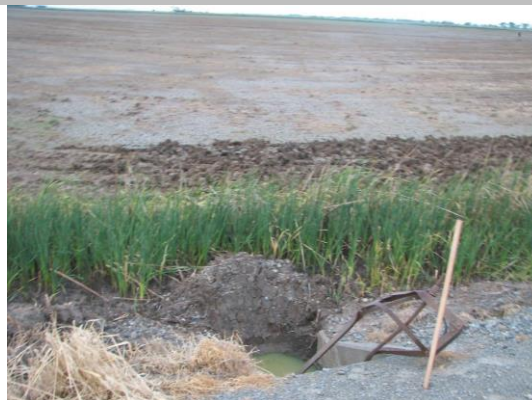
Photo 3 of 3 : UCIP\_SP\_2020\_56101\_67141.jpg

Overview of LS floor is higher in elevation than pipe invert causing build up sediment.

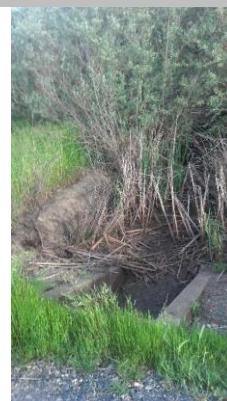
Photo 2 of 3 : UCIP\_SP\_2020\_56102\_67149.jpg

View of WS headwall with dense vegetation in channel.

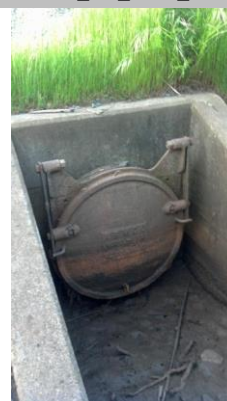
Photo 3 of 3 : UCIP\_SP\_2020\_56102\_67148.jpg

Headwall and flap gate located on WS.

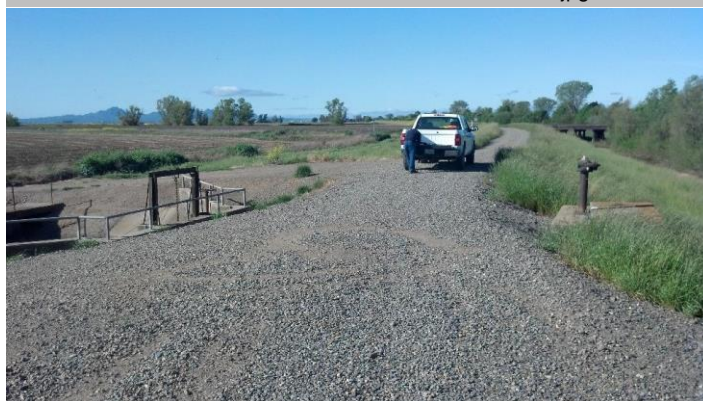
Photo 1 of 3 : UCIP\_SP\_2020\_55120\_67280.jpg

DS\_ID:16838  
FS\_ID:55120  
EP\_NO: N/A  
Repair Type: Non-Urgent  
Crossing Status: Found  
UCIP Comments: 08/28/2019 Record has been updated from No Action Needed to Non-Urgent, no permit has been identified authorizing structure. (O. Magana - DWR UCIP, A. Freitag - DWR Sutter Yard)06/05/2017 Crossing appears to be in good condition. (DWR Sutter Yard- A.Freitag)11/18/2016 Crossing appears to be in good condition. (DWR Sutter Yard- A.Freitag)04/27/2016 Crossing appears to be in good condition.06/30/2015 Path to access the WS flap gate was getting overgrown with vegetation but other than that everything with the crossing looked in good condition.05/28/2014 Same as last inspection.12/04/2013 Same as last inspection.04/24/2012 This crossing was listed in the USACE Periodic Inspection report as Corp's inspect ID# USACE\_CESPK\_M13F\_2011\_p\_0080 for limited visibility of LS slide gate and WS flap gate.07/09/2013 Same as last inspection.

Overview of levee crown at crossing looking D/S.

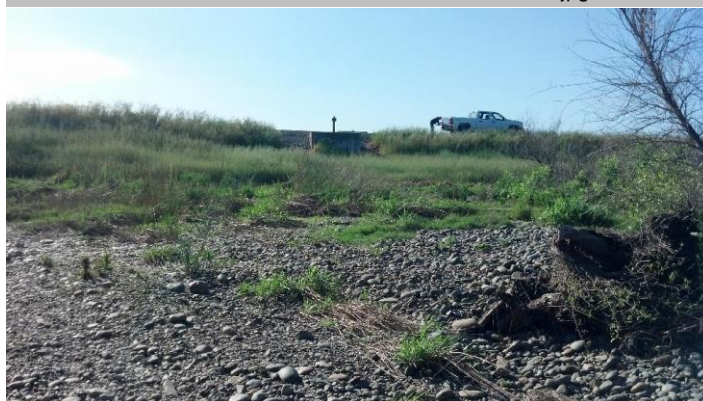
Photo 2 of 3 : UCIP\_SP\_2020\_55120\_67285.jpg

View of crossing looking from channel towards WS levee.

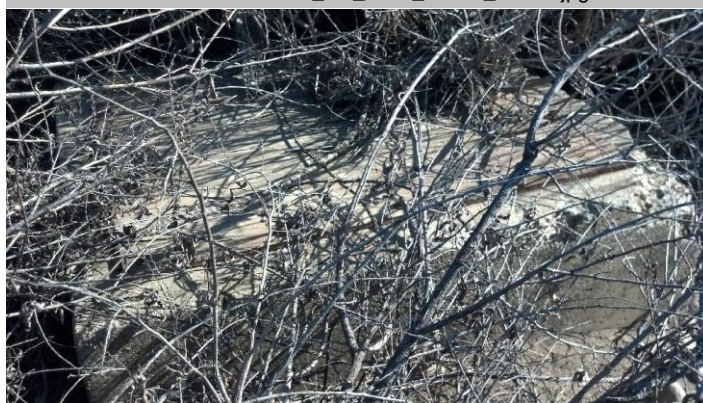
Photo 3 of 3 : UCIP\_SP\_2020\_55120\_67283.jpg

WS view-access well located 60 feet from WS toe.

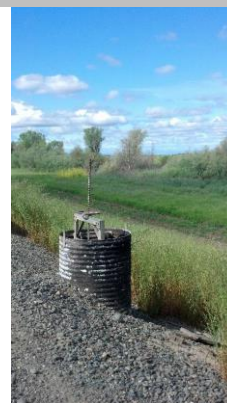
Photo 2 of 3 : UCIP\_SP\_2020\_56106\_67337.jpg

Stand pipe with screw gate WS

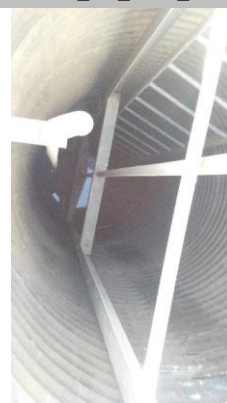
Photo 3 of 3 : UCIP\_SP\_2020\_56106\_67335.jpg

View of the inside of the WS stand pipe. No obstructions blocking slide gate.

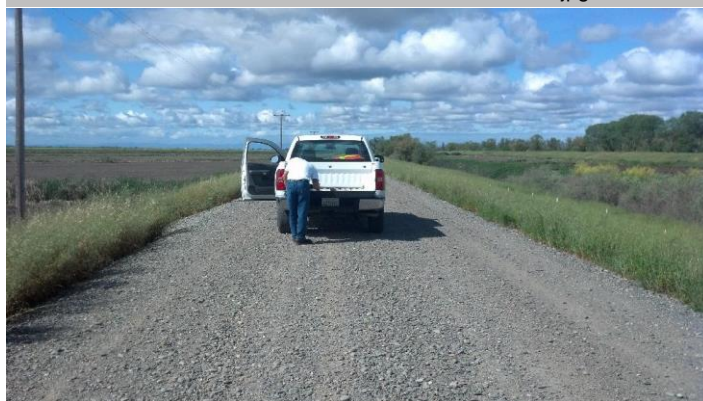
Photo 1 of 3 : UCIP\_SP\_2020\_55129\_67341.jpg

DS\_ID:16376  
FS\_ID:55129  
EP\_NO: N/A  
Repair Type: Non-Urgent  
Crossing Status: Found  
UCIP Comments: 08/29/2019 Record remains Non-Urgent, no permit has been identified authorizing pipe. Crossing appears abandoned. LMA will need to coordinate with landowner to determine is drainage structure is still needed. DMP internal inspection shows that 90% of the pipe is filled with soil at a length of about 42 feet from WS flap gate. If crossing is not in use anymore, crossing will need to be abandoned properly or removed. (O. Magana - DWR UCIP, A. Freitag - DWR Sutter Yard)5/30/2017 LS pipe end is buried and location unknown. WS flap gate is bolted shut. Pipe has been selected to be internally cleaned and inspected as part of the DMP project. (DWR Sutter Yard-AFreitag)11/17/2016 Unable to locate LS pipe end. WS flap gate bolted shut. (DWR Sutter Yard- AFreitag)4/26/2016 LS inlet appears to be buried as could not locate it. WS flap gate was bolted shut. This appears to be an abandoned crossing.6/30/2015 Still unable to locate the LS pipe end. 5/28/2014 Same as last inspection.12/4/2013 Same as last inspection. WS flap gate was bolted shut to keep LS rice field flooded.7/08/2013 WS slope has been cleared of vegetation and is in good condition. LS slope also cleared of vegetation but still very dense on LS toe and unable to locate LS headwall.4/24/2012 Could not find LS end of pipe. Limited inspection on WS and LS slopes and toe due to dense vegetation. Need photos of cleared WS and LS slopes, and LS headwall during next inspection. This crossing was listed in the USACE Periodic Inspection report as Corp's inspect ID# USACE\_CESPK\_M13E\_2011\_p\_0011 for WS gate blocked by vegetation.

Overview of crossing looking downstream at the left bank of Cherokee Canal.

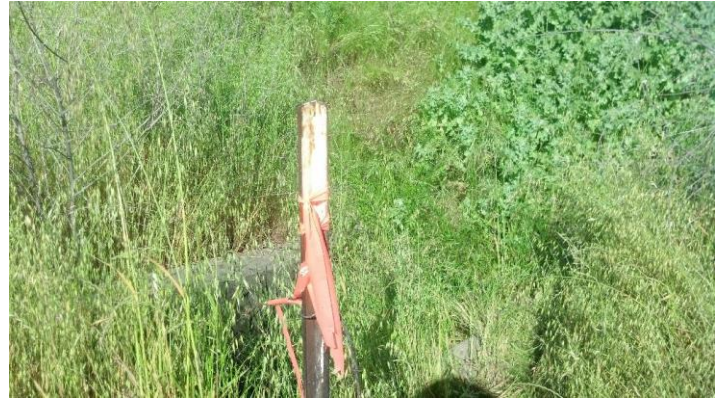
Photo 2 of 3 : UCIP\_SP\_2020\_55129\_67343.jpg

Dense vegetation covering the majority of the WS. WS headwall difficult to see through dense vegetation.

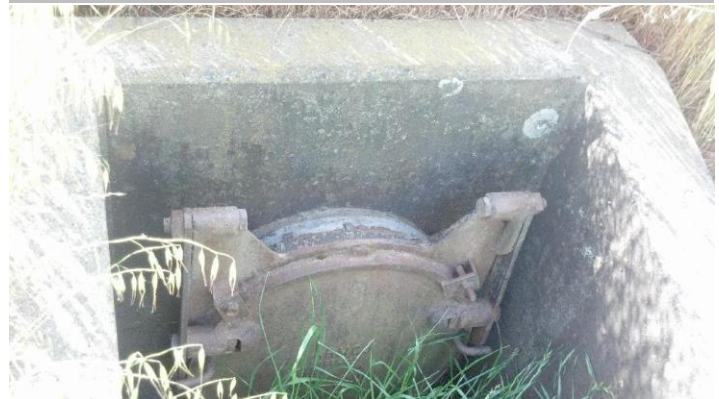
Photo 3 of 3 : UCIP\_SP\_2020\_55129\_67342.jpg

View of WS headwall and flap gate.

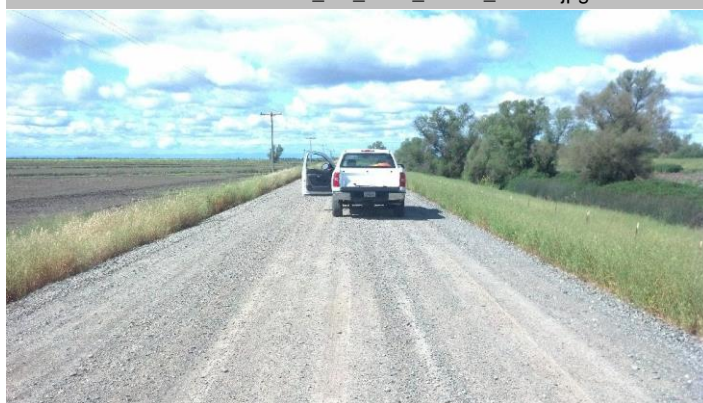
Photo 1 of 3 : UCIP\_SP\_2020\_55974\_67352.jpg

FIELD\_STRUCT\_DESC: \*ABANDONED\* 24-inch corrugated metal drainage pipe through the levee, 9 feet below the crown. Flap gate located on the waterside (WS) end. Concrete "U" headwalls on both WS and landside (LS). WS gate bolted shut and LS crossing is non-operable (inlet not found). Additional Reference(s): DWR Levee Log, 1993 (HLM 15.87). USACE Sacramento O&M Manual 519, June 1962 (HLM 15.87), As-built DWG No. 50-4-3511, Sheet No. 3511/8.3, STA 392+42E, page 8 of 31 electronic file, listed as 24-inch CMP; As-built DWG No 50-4-3037 referenced not available]

Overview of crossing looking downstream of the left bank of Cherokee

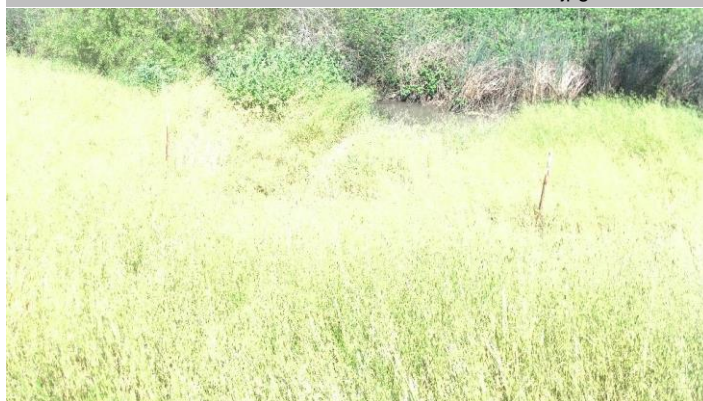
Photo 2 of 3 : UCIP\_SP\_2020\_55974\_67351.jpg

View of WS slope. Limited inspection due to the dense vegetation.

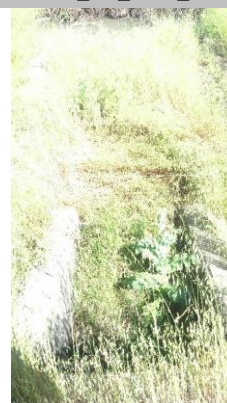
Photo 3 of 3 : UCIP\_SP\_2020\_55974\_67350.jpg

View of WS headwall.

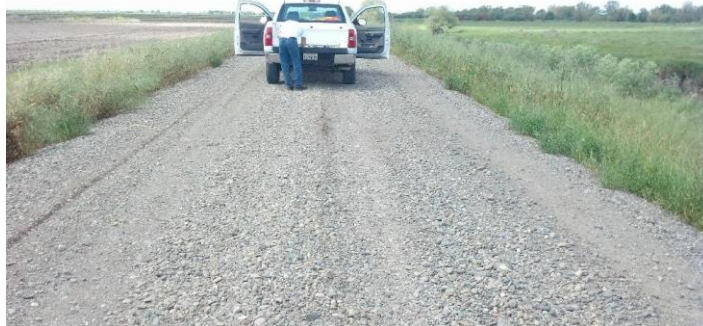
Photo 1 of 3 : UCIP\_SP\_2020\_55133\_67387.jpg

DS\_ID:16379  
FS\_ID:55133  
EP\_NO: N/A  
Repair Type: Non-Urgent  
Crossing Status: Found  
UCIP Comments: 08/29/2019 Record has been updated from No Action Needed to Non-Urgent, no permit has been identified authorizing pipe. Pipe is under water. Pipe is scheduled to be lined. (O. Magana - DWR UCIP, A. Freitag - DWR Sutter Yard)05/30/2017 Crossing appears to be in good condition. Pipe has been selected to be internally cleaned and inspected as part of the DMP project. (DWR Sutter Yard- A.Freitag)11/17/2016 Crossing appears to be in good condition. (DWR Sutter Yard- A.Freitag)04/26/2016 Crossing appears to be in good condition.06/30/2015 Vegetation still present on WS. LS side was underwater during inspection.05/28/2014 Same as last inspection.12/04/2013 Same as last inspection.07/08/2013 LS slope cleared of vegetation and is in good condition. WS is still vegetated. LS pipe end under water and blocked off by plywood so unable to measure culvert size.04/24/2012 Limited inspection on WS and LS slopes due to dense vegetation. Need photos of cleared WS and LS slopes. This crossing was listed in the USACE Periodic Inspection report as Corp's inspect ID# USACE\_CESPK\_M13E\_2011\_p\_0134 for unknown culvert size on LS and no outlet visible on WS.

Overview of crossing looking D/S at left bank of Cherokee Canal.

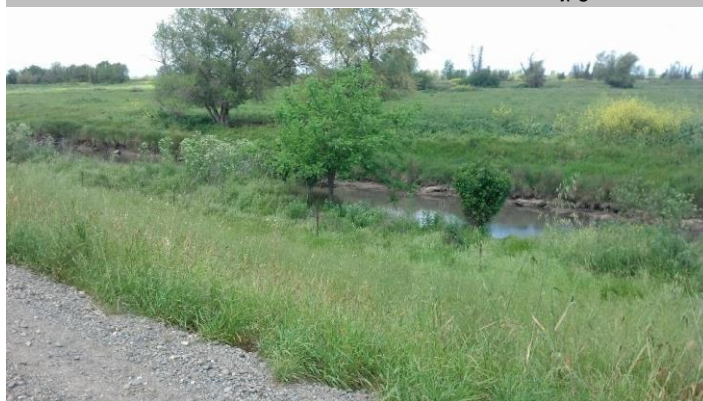
Photo 2 of 3 : UCIP\_SP\_2020\_55133\_67386.jpg

View of WS slope and berm.

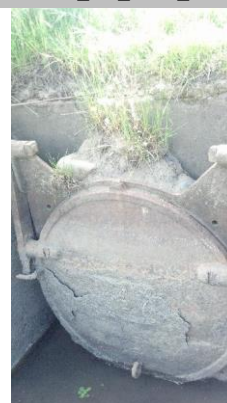
Photo 3 of 3 : UCIP\_SP\_2020\_55133\_67390.jpg

View of flap gate located on WS.

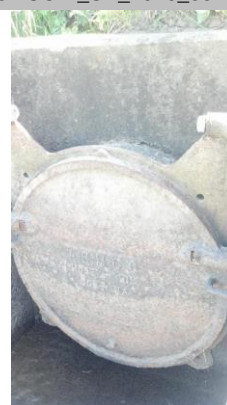
Photo 3 of 3 : UCIP\_SP\_2020\_55135\_67402.jpg

Flap gate located on the WS.

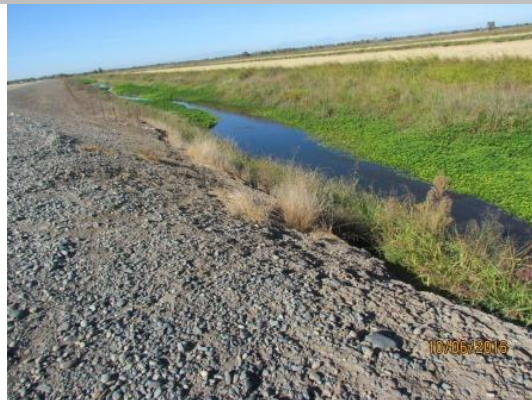
Photo 1 of 1 : SP\_2020\_MA0013\_301\_75\_20200226\_00013.jpg

LM Start	20.77	Rating **	M	Issue No.	75
LM End	20.77	Issue Type +	Ma	Location *	WS
Category	Earthen Levee			GPS Latitude/Longitude	
				Start	End
Item	Erosion / Bank Caving			39.370641 °	39.370641 °
				-121.850572 °	-121.850572 °
DWR ID	DWR_MA0013_02_f_2016_75				
Comment Code					
E2 : Schedule repair of erosion site prior to the next inspection.					
Inspector Comment

View of the erosion along the waterside toe.

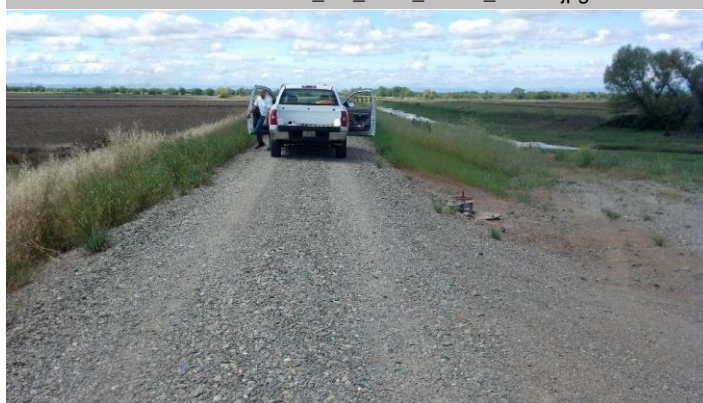
Photo 1 of 3 : UCIP\_SP\_2020\_55413\_67447.jpg

DS\_ID:16384  
FS\_ID:55413  
EP\_NO: N/A  
Repair Type: Non-Urgent  
Crossing Status: Found  
UCIP Comments: 08/29/2019 Record remains Non-Urgent due to unauthorized encroachment with recent modifications. Structure type needs to be corrected from Drainage to Irrigation. During inspection water was flowing from WS to LS to irrigate the rice fields. Structure has been modified since 2012, unable to determine extent of repair through levee. Need to contact owner to determine section replaced through levee. Structure is not maintained or operated by LMA-DWR Sutter Yard. (O. Magana - DWR UCIP, A. Freitag - DWR Sutter Yard)05/30/2017 Crossing appears to be in good condition. Pipe has been selected to be internally cleaned and inspected as part of the DMP project. (DWR Sutter Yard - A.Freitag)11/17/2016 Pipe section that crosses through the levee appears to be in good condition. (DWR Sutter Yard - A.Freitag)04/26/2016 Pipe appears to have been repaired. Not sure on the extent of the repairs or if they were approved by the Central Valley Flood Control Board.06/30/2015 Pipe is currently undergoing repairs. Not sure what all is planned to be fixed but will update the photos and inspection report with new details when its completed.05/28/2014 Same as last inspection.12/04/2013 Same as last inspection.07/08/2013 Pipe appears to have been repaired. Need to talk to inspections and supervisor to find out more details on repair.04/24/2012 Needs repair. Internal piping, severe corrosion. Debris present--rusted pipe stockpiled on LS slope. Limited inspection on WS and LS slopes due to dense vegetation. Need photos of cleared WS & LS slopes. This crossing was listed in the USACE Periodic Inspection report as Corp's inspect ID# USACE\_CESPK\_M13E\_2011\_p\_0234 for no WS gate but sluice gate present.

FIELD\_STRUCT\_DESC: 24-inch corrugated metal irrigation pipe through the levee, 8.2 feet below the crown. Crossing penetrates levee at angle. Slide gate in corrugated metal pipe (CMP) riser on the waterside (WS) slope. Pipe crosses the channel. Corroded section of existing pipe, 9-foot and 8-inch of an 18-inch corrugated metal pipe section, was replaced under Permit 7231 prior to 1974. (24-inch CMP authorized to match existing 24-inch CMP through left bank under Permit No. 7231, 1960 - Estate of Walter L. King) [Additional Reference(s): DWR Levee Log, 1993 (HLM 21.60). USACE Sacramento O&M Manual 519, June 1962 (HLM 21.60), As-built DWG No. 50-4-3511, Sheet No. 3511/22, STA 93+21E, page 22 of 31 electronic file, listed as 24-inch CMP section through the levee (irrigation structure); As-built DWG No. 50-4-3037 referenced not available]  
FS Date: 8/29/2019 7:39:00 AM

Overview of crossing looking downstream.

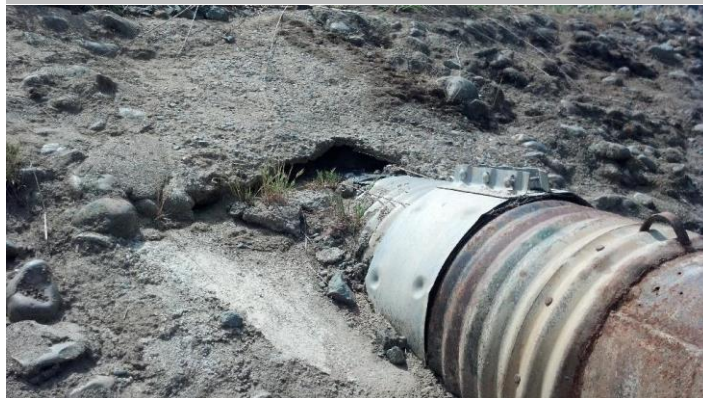
Photo 2 of 3 : UCIP\_SP\_2020\_55413\_67451.jpg

View of WS daylight. Hole present at pipe daylight.

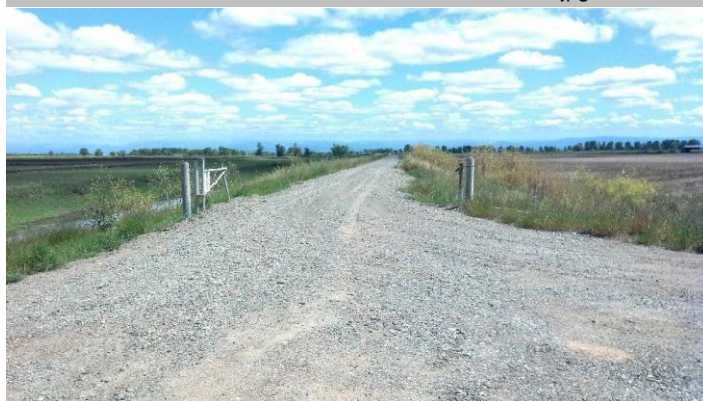
Photo 1 of 3 : UCIP\_SP\_2020\_55414\_67462.jpg

DS\_ID:16394  
FS\_ID:55414  
EP\_NO: N/A  
Repair Type: Non-Urgent  
Crossing Status: Found  
UCIP Comments: 08/29/2019 Record remains Non-Urgent, no permit has been identified authorizing pipe. Pipe has been lined and a new flap gate has been installed on the WS. (O. Magana - DWR UCIP, A. Freitag - DWR Sutter Yard)05/30/2017 WS flap gate showing signs of rusting and deterioration but still appears to be able to function properly. Pipe has been selected to be internally cleaned and inspected as part of the DMP project. (DWR Sutter Yard - A.Freitag)11/17/2016 WS flap gate is really rusted and deteriorated but it appears to still function properly. (DWR Sutter Yard - A.Freitag)04/26/2016 WS flap gate is really rusted and deteriorated. May need to be replaced. The rest of the crossing appeared in good condition.06/30/2015 Crossing is in good condition. No noticeable issues to be reported.05/28/2014 Same as last inspection.12/04/2013 WS and LS slopes are in good condition.07/08/2013 Same as last inspection.04/24/2012 Limited inspection on WS and LS slopes due to dense vegetation. Need photos of cleared WS and LS slopes. This crossing was listed in the USACE Periodic Inspection report as Corp's inspect ID# USACE\_CESPK\_M13E\_2011\_p\_0251 for no outlet visible on WS. FIELD\_STRUCT\_DESC: 24-inch CIPP-lined corrugated metal drainage pipe through the levee, 11.6 feet below the crown. Flap gate on the waterside (WS) end. Concrete "U" headwalls on both WS and landside (LS). Rusted gate located on the WS (gate stuck). [Additional Reference(s): DWR Levee Log, 1993 (HLM 22.08). USACE Sacramento O&M Manual 519, June 1962 (HLM 22.08), As-built DWG No. 50-4-3511, Sheet No. 3511/2.2 and 31.2, STA 67+70E, page 2, 31 of 31 electronic file, listed as 24-inch CMP section through the levee] FS Date: 8/29/2019 7:40:00 AM

Overview of crossing looking upstream at the left bank of Cherokee Canal.

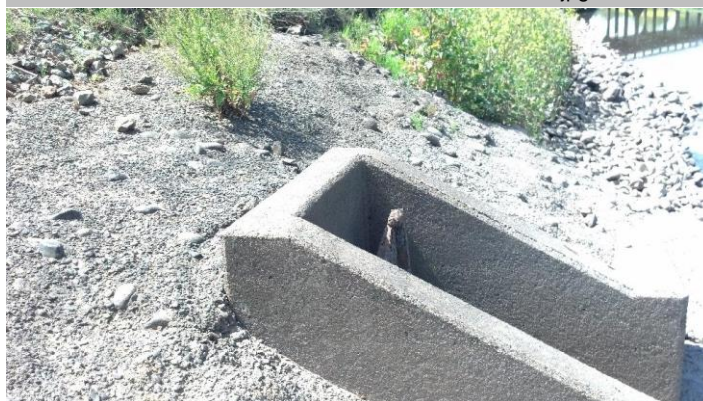
Photo 2 of 3 : UCIP\_SP\_2020\_55414\_67460.jpg

View of WS headwall.

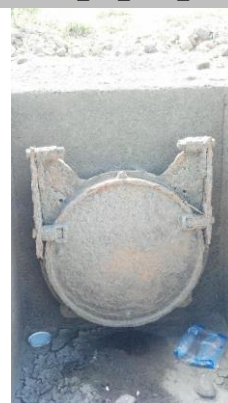
Photo 3 of 3 : UCIP\_SP\_2020\_55414\_67461.jpg

Flap gate located on WS.

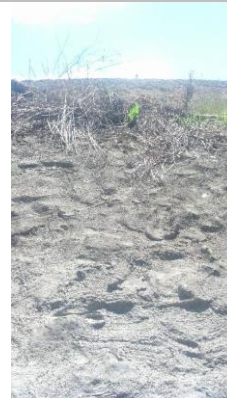
Photo 1 of 3 : UCIP\_SP\_2020\_56064\_67498.jpg

DS\_ID:16391  
FS\_ID:56064  
EP\_NO: N/A  
Repair Type: Non-Urgent  
Crossing Status: Found  
UCIP Comments: 08/29/2019 Record remains Non-Urgent, no permit has been identified authorizing pipe. WS outlet is blocked by dense vegetation. LS inlet is still unknown. DWR Geophysical Survey was unable to confirm alignment. Need to contact property owner to determine if crossing is still being used and confirm pipe alignment. (O. Magana - DWR UCIP, A. Freitag - DWR Sutter Yard)05/30/2017 Location of LS inlet still unknown. Need to trace with utility locator/GPR to find. Pipe has been selected to be internally cleaned and inspected as part of the DMP project. (DWR Sutter Yard - A.Freitag)11/17/2016 Unable to locate LS pipe end. WS appears to be in good condition. (DWR Sutter Yard - A.Freitag)04/26/2016 Still unable to locate the LS headwall and end of pipe. Pipe is still being used. Pipe was draining to WS.06/30/2015 Still unable to locate the LS headwall and pipe end.05/28/2014 Same as last inspection.12/04/2013 Same as last inspection.07/08/2013 Same as last inspection. Unable to locate LS headwall.04/24/2012 Unable to locate LS headwall. Need photo of LS headwall during next inspection.

View of WS slope looking from WS headwall to levee crown.

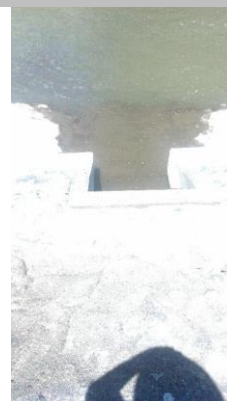
Photo 2 of 3 : UCIP\_SP\_2020\_56064\_67496.jpg

View of WS slope looking from WS headwall to levee crown.

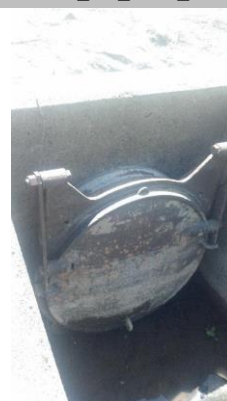
Photo 3 of 3 : UCIP\_SP\_2020\_56064\_67497.jpg

View of flap gate on WS.

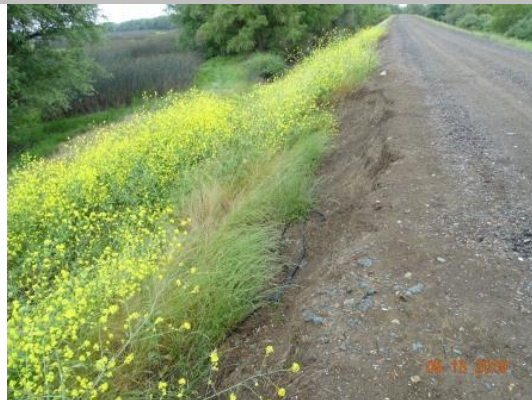
Photo 1 of 1 : SP\_2020\_MA0013\_301\_61\_20200226\_00010.jpg

LM Start	22.58	Rating **	U	Issue No.	61
LM End	22.58	Issue Type +	Ma	Location *	LS
Category	Earthen Levee			GPS Latitude/Longitude	
				Start	End
Item	Erosion / Bank Caving			39.356476 °	39.356476 °
				-121.879089 °	-121.879089 °
DWR ID	DWR_MA0013_02_s_2019_61				
Comment Code					
E2 : Schedule repair of erosion site prior to the next inspection.					
Inspector Comment

View of the erosion at the landside shoulder and slope. Spring 2019.
